2018 Inspection Report of Storm Water Management System

*Grand Traverse Town Center
Acme Township, Grand Traverse County
Michigan*

September 2018

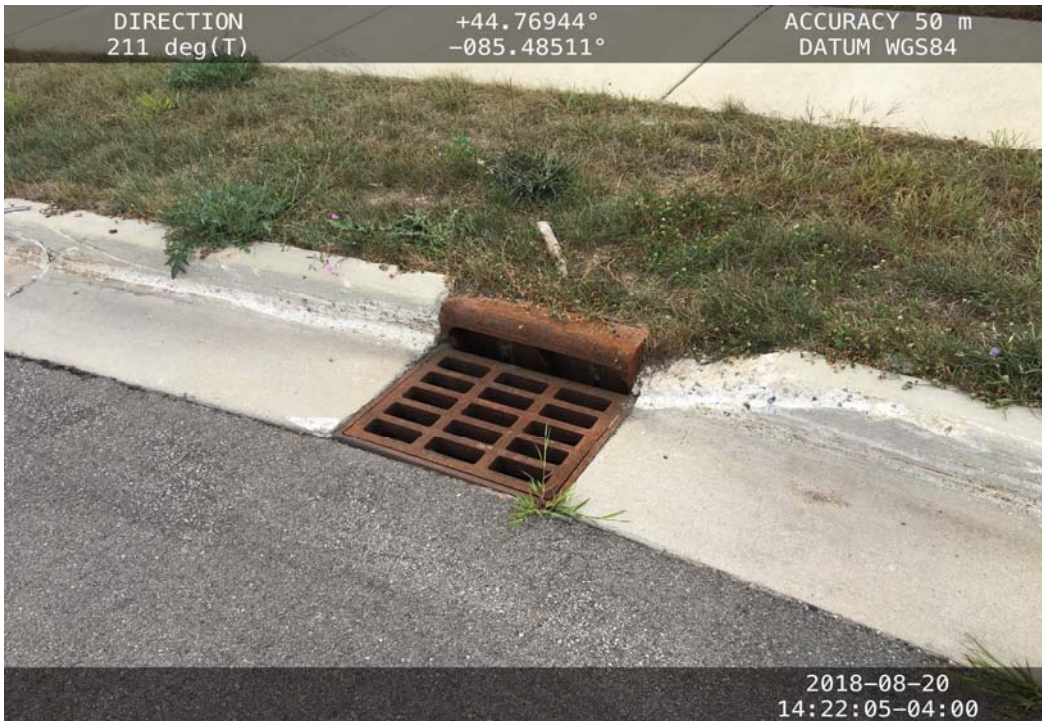
Catch Basin Inlets: The catch basin inlet structures were inspected and compared to the as-built plans for the SWMS, and no discrepancies were noted. No evidence of floatables or debris was observed in the catch basins or near the catch basin inlets.

Photo 1: Catch basin inlet west corridor road

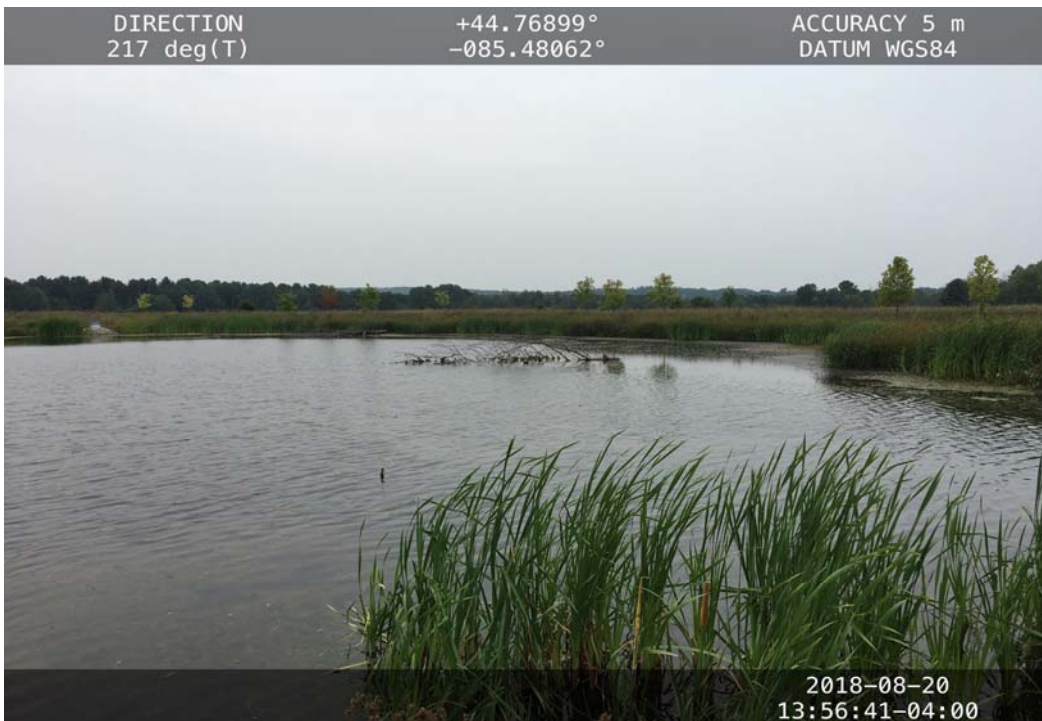
Storm Water Detention Areas: The storm water detention areas (Basin 1 and 2, and swale expansion areas) were inspected and compared to the as-built plans for the SWMS, and no discrepancies were noted. No evidence of sediment accumulation, floatables, debris or signs of erosion were observed in the storm water detention areas.

Photo 2: Basin # 1 detention pond viewing south

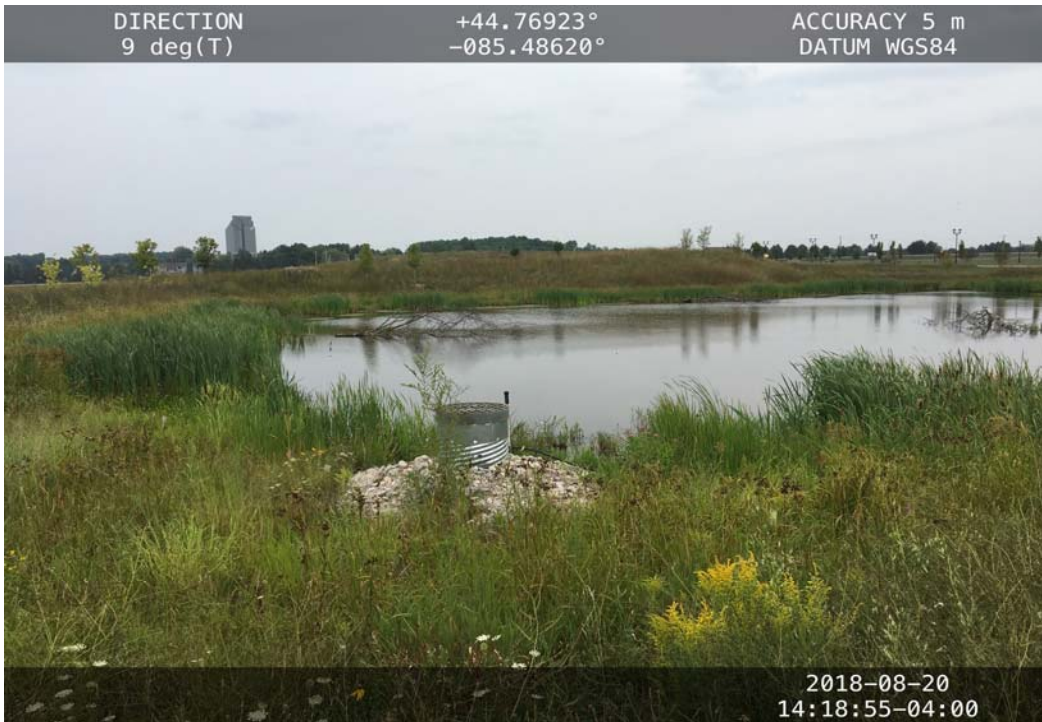
Photo 3: Basin # 2 detention pond viewing north

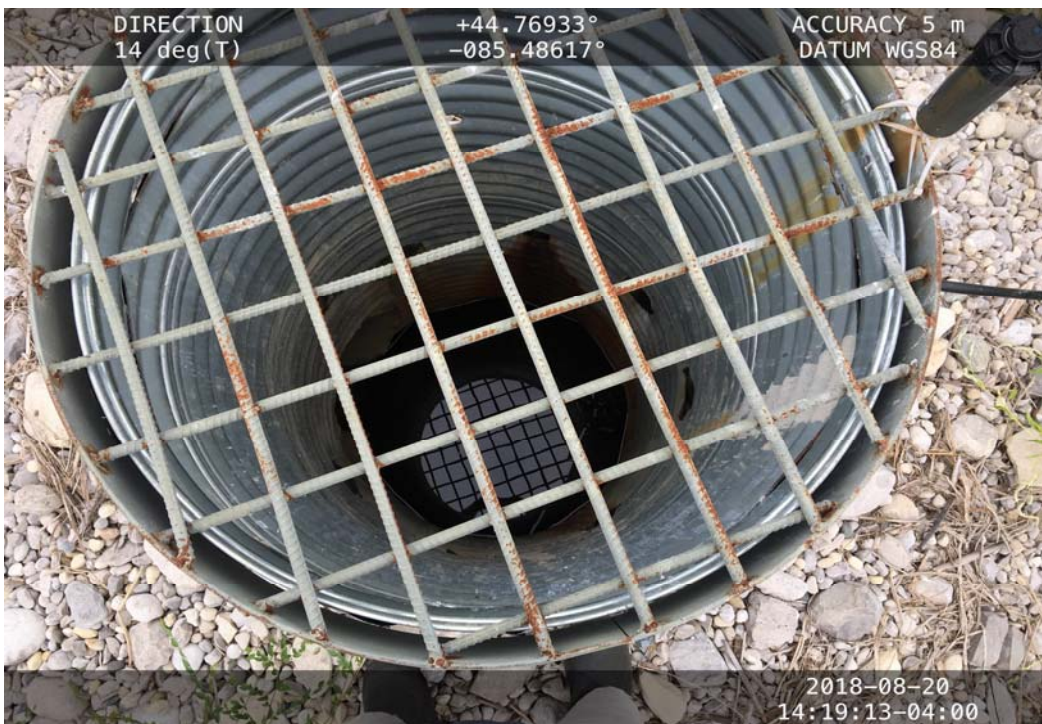
Outflow Control Structures: The outflow control structures were inspected and compared to the as-built plans for the SWMS, and no discrepancies were noted. Both Basin 1 and Basin 2 were discharging water from the ponds at the time of the inspection. No evidence of sediment accumulation, floatables, or debris were observed in the either of the basin outflow control structures or pond outlet/swale inlet structures. No evidence of erosion was observed at the pond outlet/swale inlet structures.

Photo 4: Basin # 1 outflow control structure (exterior)

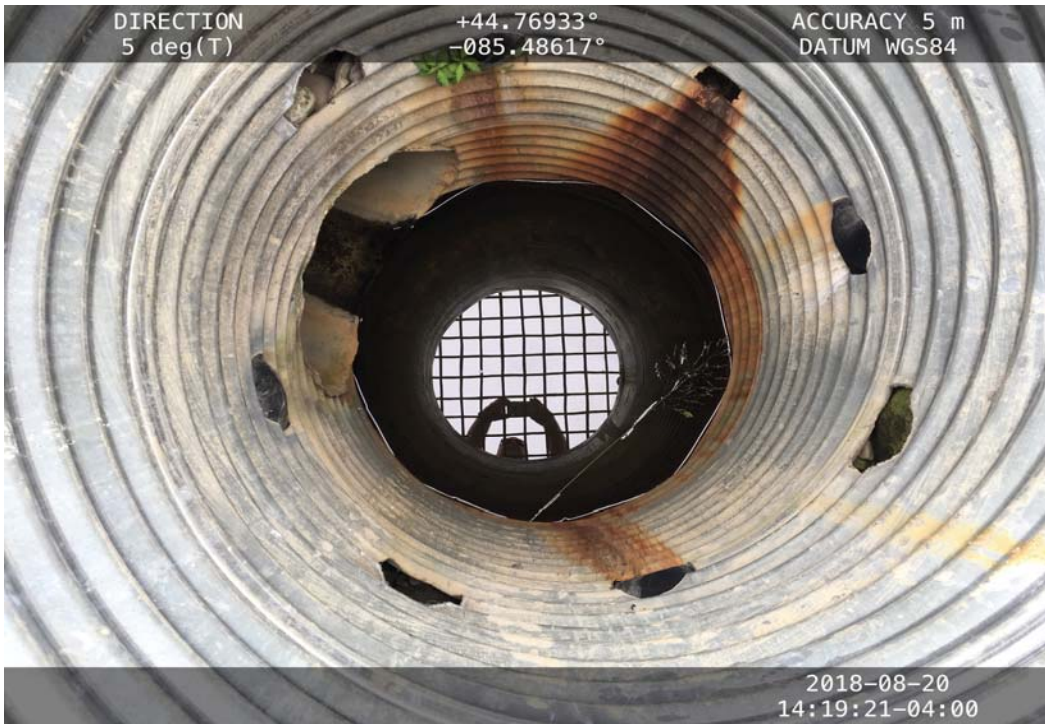
Photo 5: Basin # 1 outflow control structure (interior)

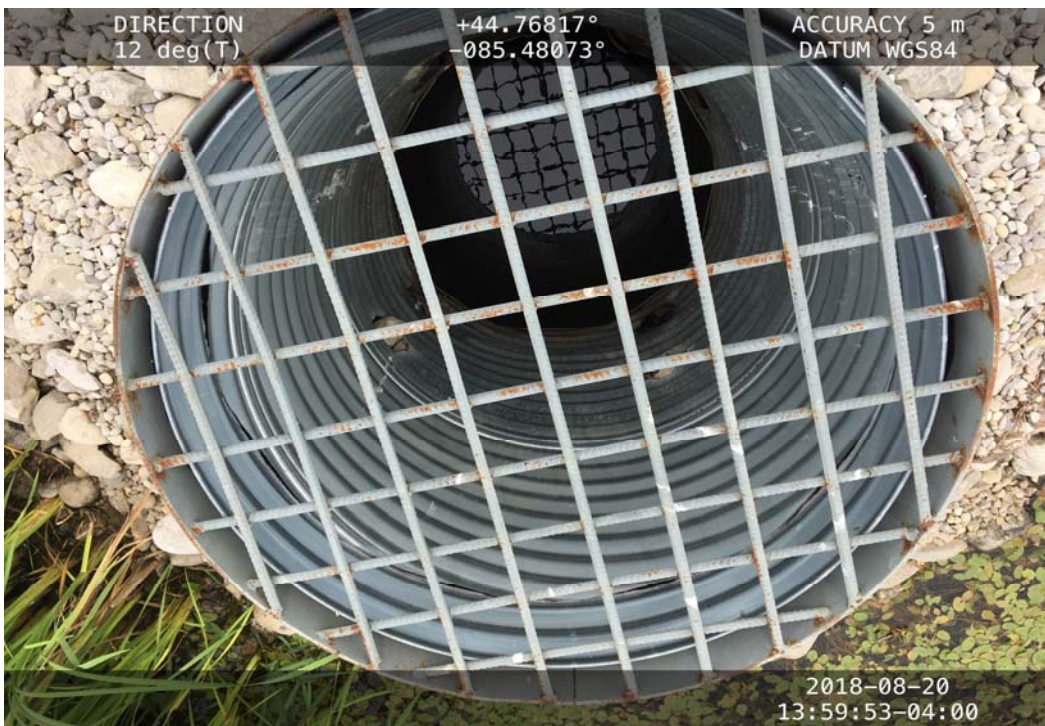
Photo 6: Basin # 2 outflow control structure (exterior)

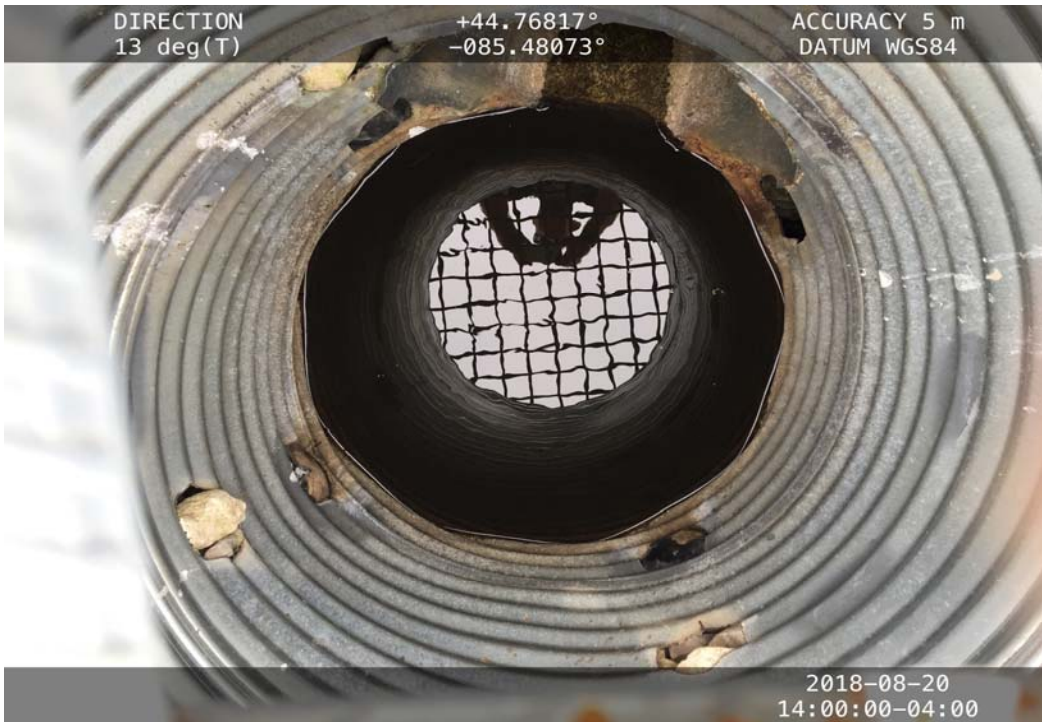
Photo 7: Basin # 2 outflow control structure (interior)

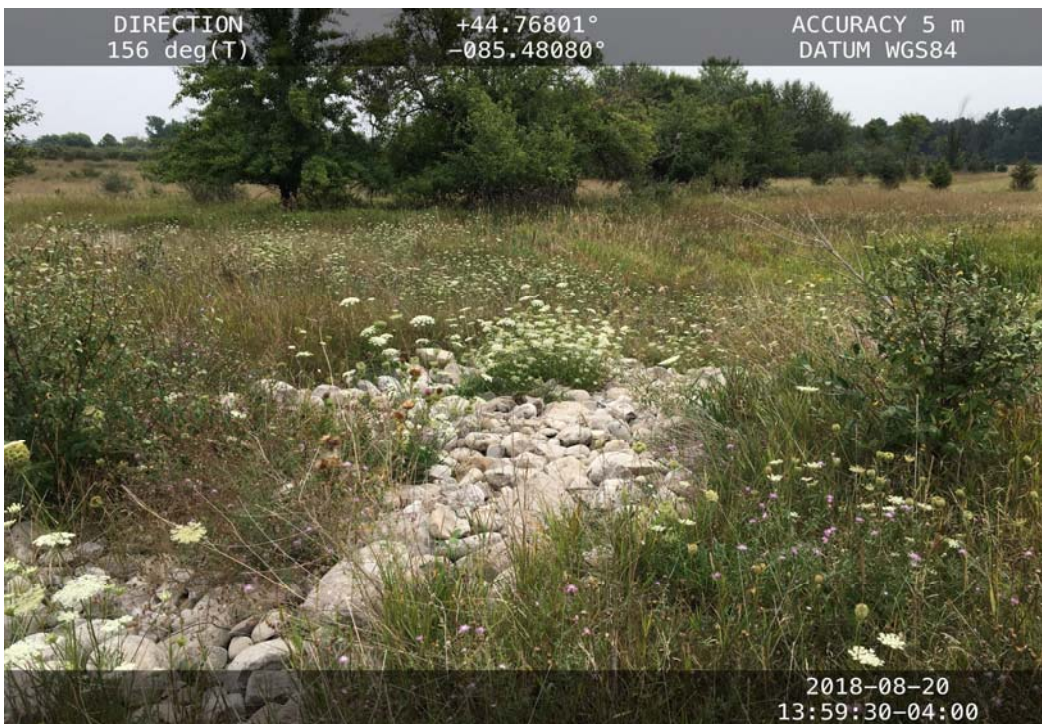
Emergency Outflows: The emergency outflows were inspected and compared to the as-built plans for the SWMS, and no discrepancies were noted.

Photo 8: Basin # 1 emergency overflow

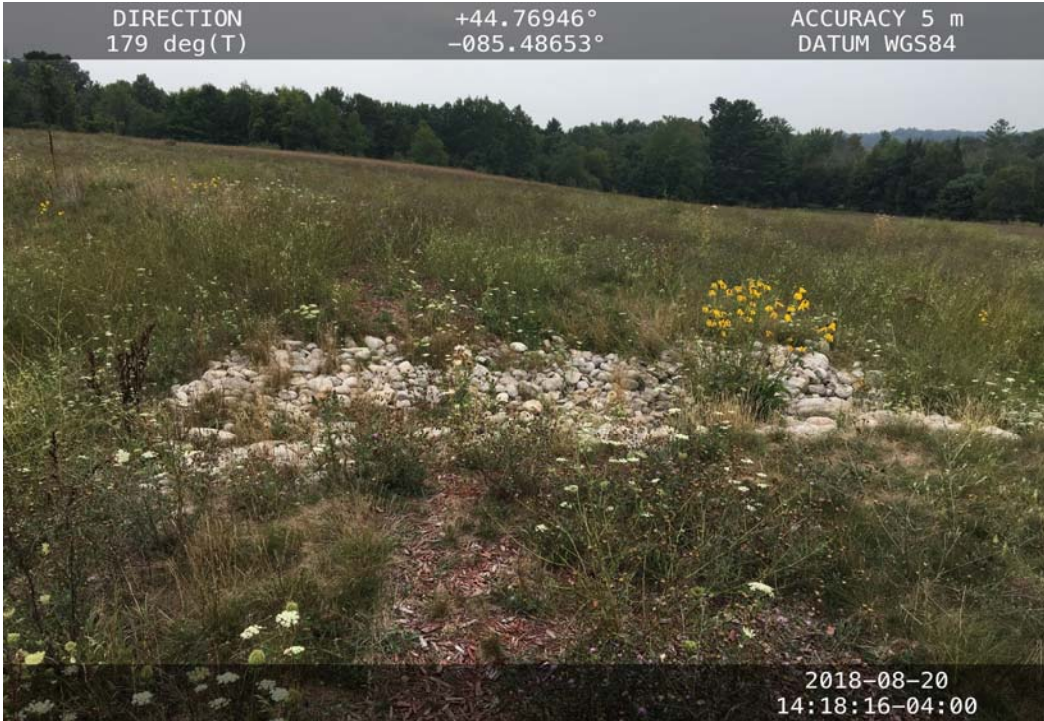
Photo 9: Basin # 2 emergency overflow

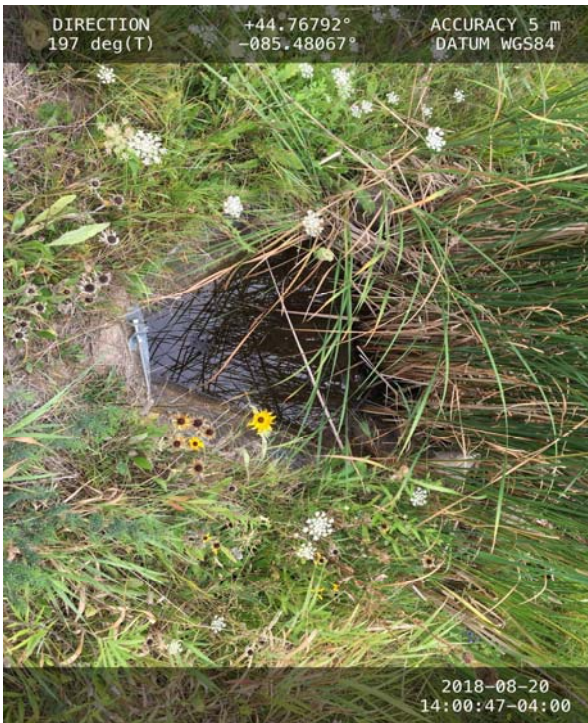
Photo 10: Basin # 1 swale inlet structure

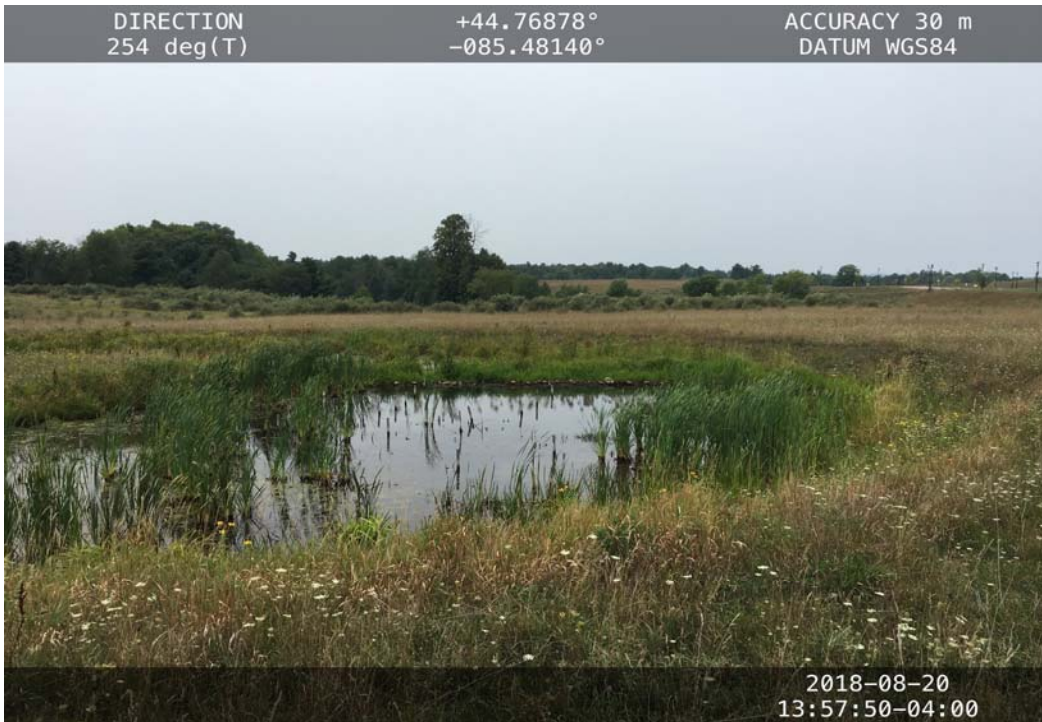
Riprap: The riprap (check dams and outflow aprons) associated with the SWMS were inspected and compared to the as-built plans for the SWMS, and no discrepancies were noted.

Photo 11: Basin # 1 swale expansion area/riprap check dam

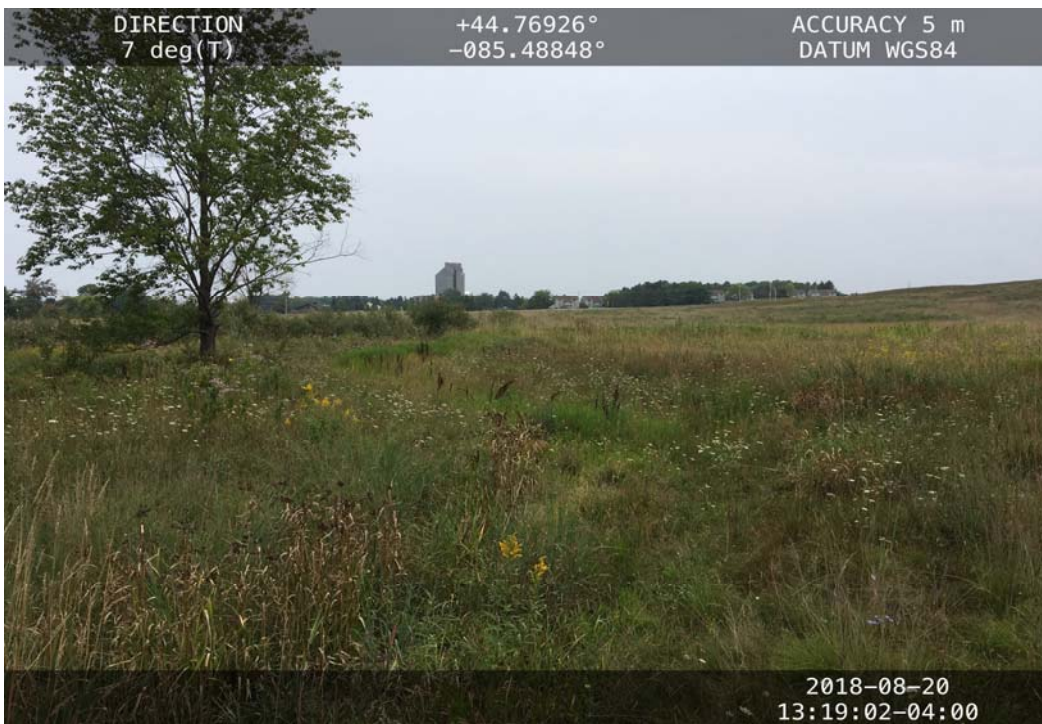
Swales: The swales were inspected and compared to the as-built plans for the SWMS, and no discrepancies were noted. The vegetation in both swales was well established and no evidence of sediment accumulation, floatables, or debris were observed in the either of the basin swales. No evidence of erosion was observed in either of the basin swales.

Photo 12: Basin # 2 swale viewing north

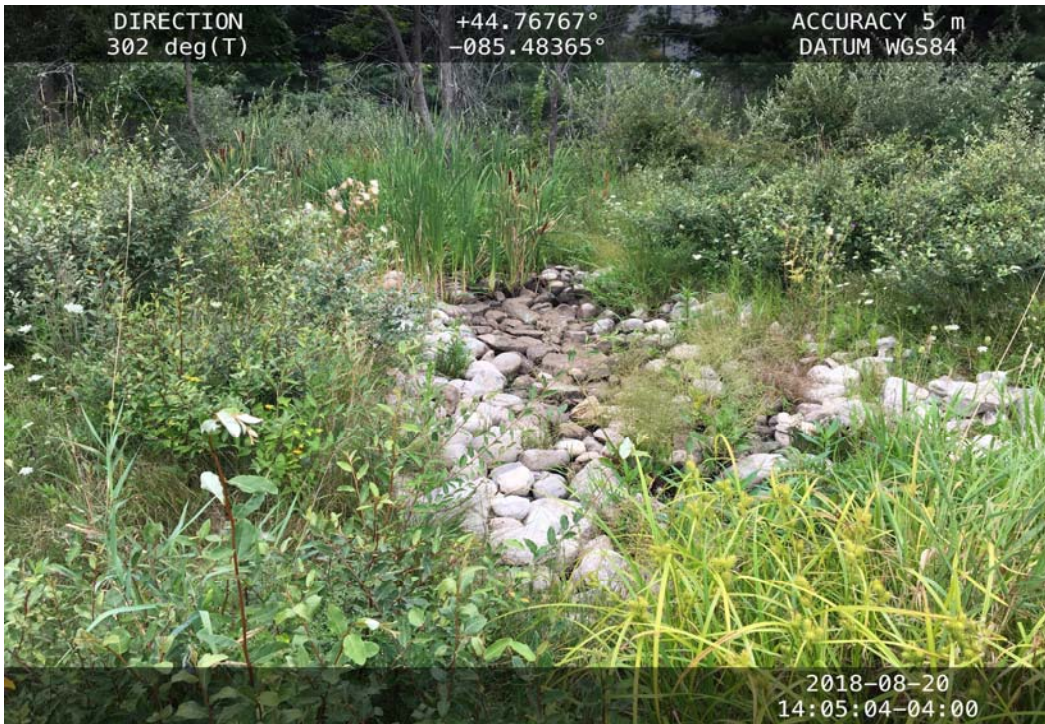
Photo 13: Basin # 1 swale outlet

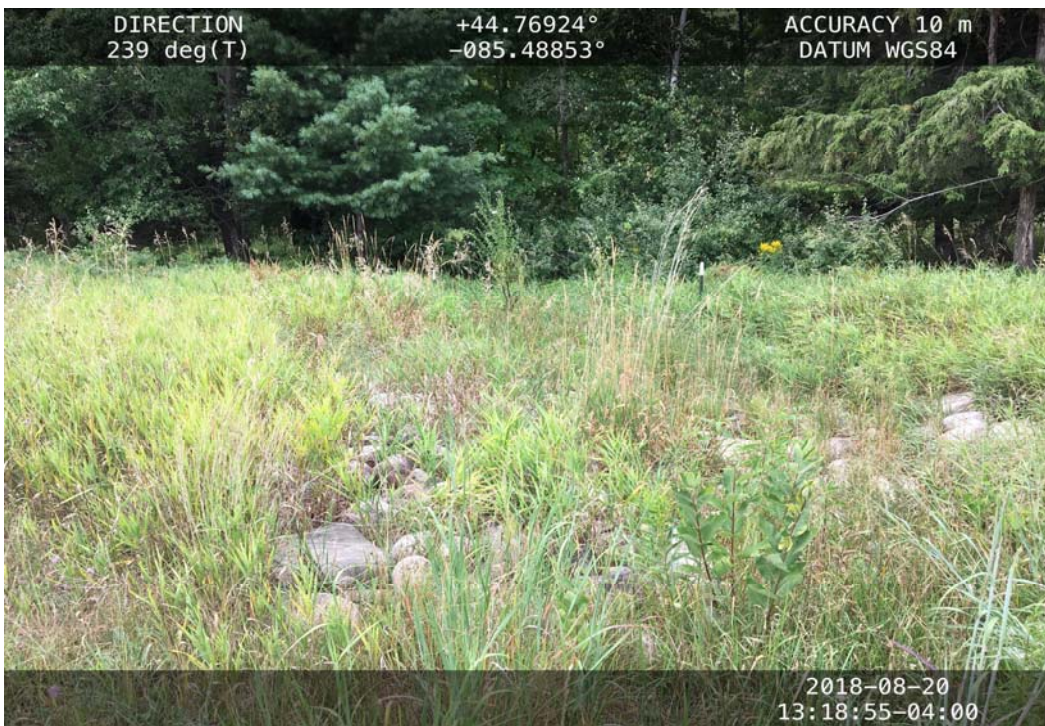
Photo 14: Basin # 2 swale outlet
